DOT HS 807 335  
Final Report

**MDB-To-Car-Side Impact Test of A 26° Crabbed  
Moving Deformable Barrier to A 1985 Chevrolet  
Celebrity at 33.1 MPH**

Technical Report Documentation Page

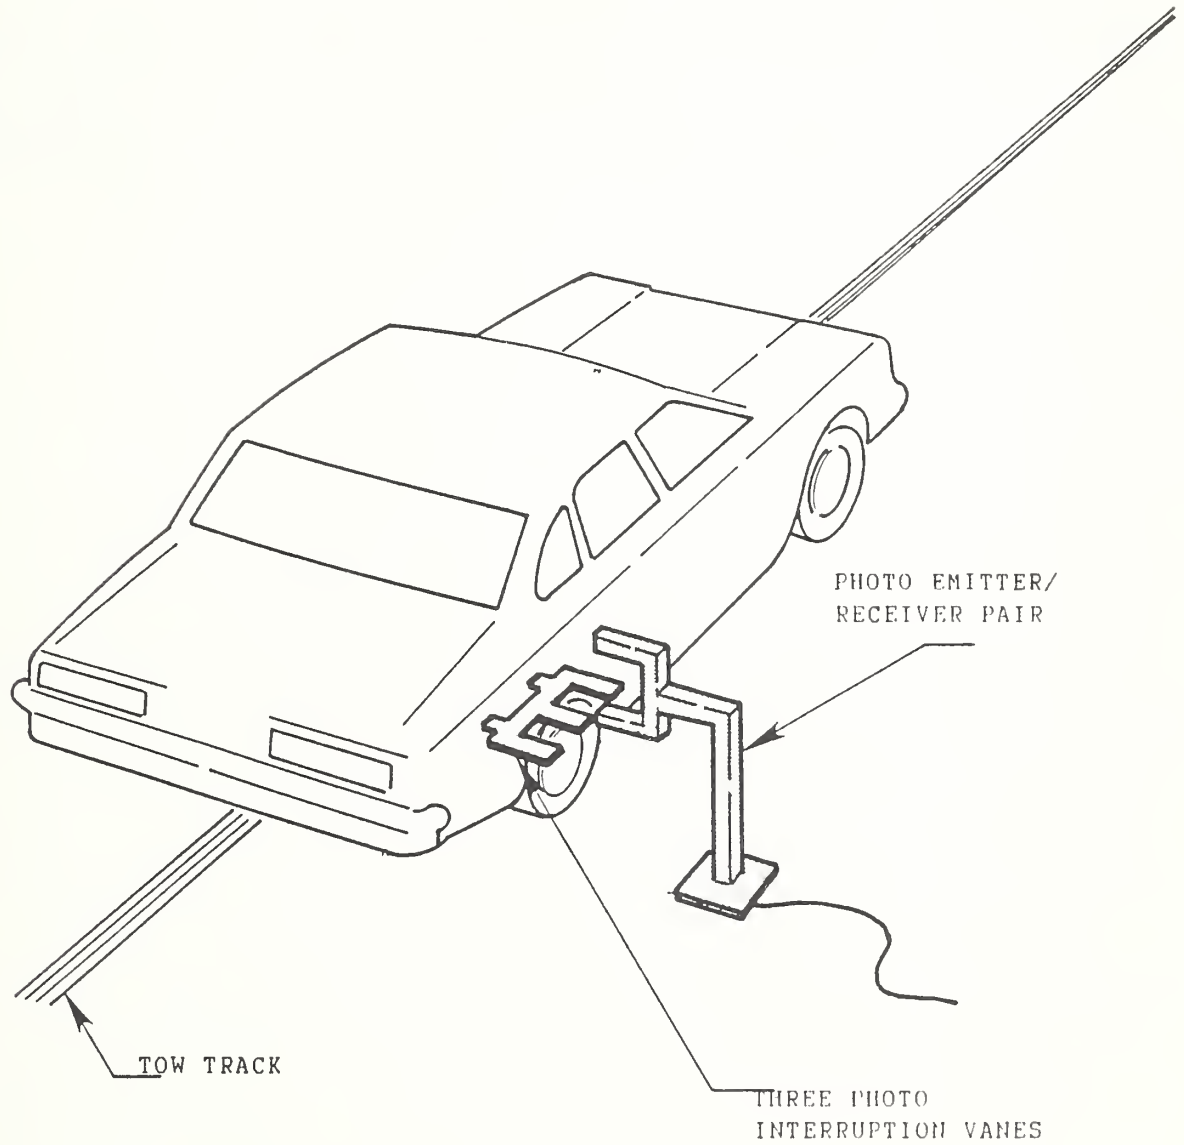
IMPACT VELOCITY MEASUREMENT SYSTEM

The final vane clears emitter/receiver two inches before impact.

The vanes have one foot spacing.

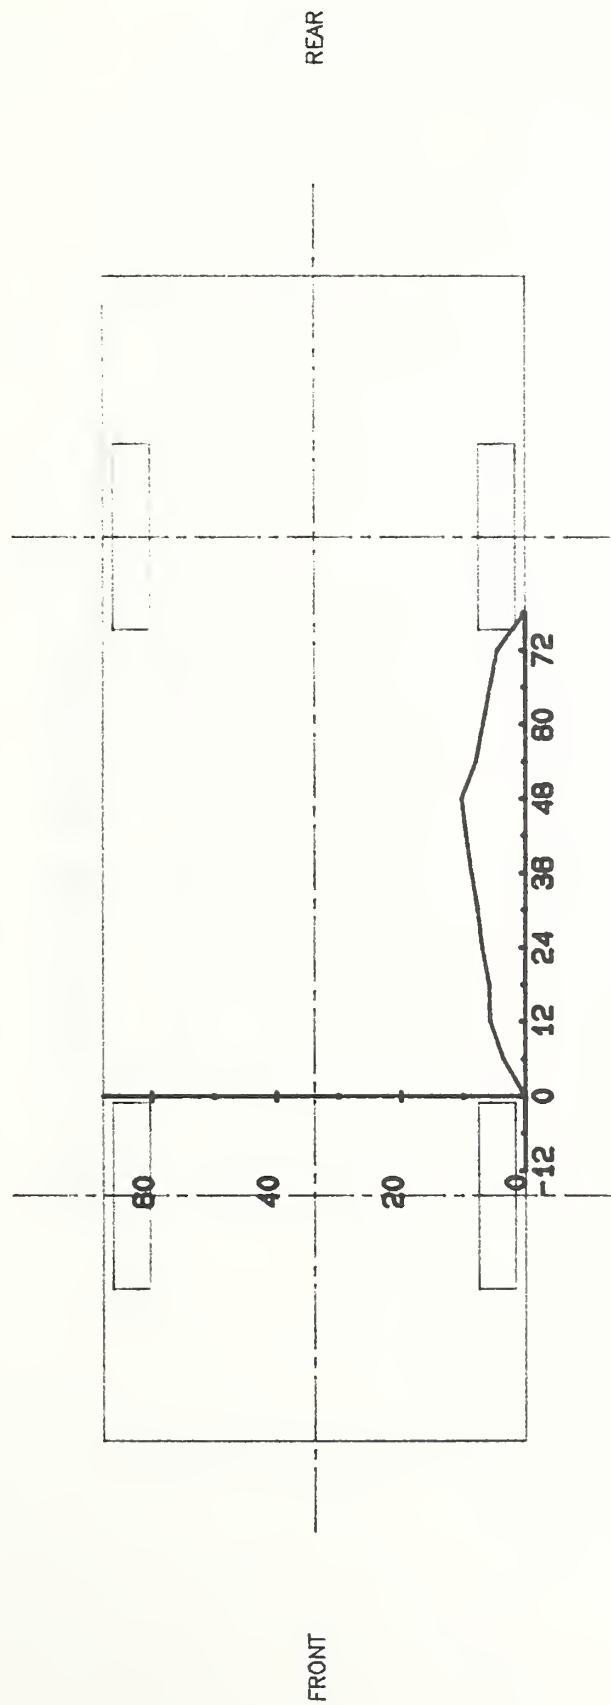
# VEHICLE EXTERIOR STATIC CRUSH PROFILE

PROFILE LEVEL EQUALS AXLE HEIGHT WHICH IS 11.2" ABOVE GROUND LEVEL  
 (0,0) EQUALS PROJECTED IMPACT POINT  
 SCALE FACTOR EQUALS 0.034

LOCATION	HEIGHT (IN)	6	0	6	12	18	24	30	36	42	48	54	60	66	72	78
PRE-TEST PROFILE (DISTANCE IN INCHES FROM REFERENCE PLANE**)																
Axle Height	11.2	NA	NA	17.9	17.9	17.9	17.9	18.0	17.8	17.8	17.8	17.8	17.6	17.5	17.7	NA
H-Point	20.1	NA	13.7	13.7	13.6	13.5	13.5	13.5	13.5	13.5	13.5	13.6	13.6	13.7	13.8	NA
Mid Door	23.6	NA	14.0	14.1	14.0	13.9	13.9	13.8	13.8	13.8	13.8	13.9	13.9	14.0	14.1	14.0
Window Sill	35.4	16.0	16.1	16.0	16.0	16.0	16.0	15.9	15.8	15.8	15.8	15.8	15.9	16.0	16.1	16.1
Window Top	53.1	NA	NA	NA	NA	NA	NA	23.9	24.1	24.2	24.6	24.7	24.5	24.5	24.5	24.6
POST-TEST PROFILE (DISTANCE IN INCHES FROM REFERENCE PLANE**)																
Axle Height	11.2	NA	NA	21.3	23.5	23.7	24.8	25.6	26.4	27.4	28.0	25.8	24.4	23.1	22.2	NA
H-Point	20.1	NA	15.5	20.8	27.0	28.4	29.0	29.1	29.4	29.0	29.5	29.5	29.5	29.1	26.6	NA
Mid Door	23.6	NA	15.8	22.4	24.9	25.8	26.1	26.6	26.6	26.5	27.1	27.4	27.0	27.1	26.5	19.2
Window Sill	35.4	17.5	17.6	19.5	20.1	24.0	25.1	25.4	25.4	25.5	26.5	26.2	26.1	26.5	25.0	20.2

Window Top	53.1	NA	NA	NA	NA	NA	NA	27.0	27.5	28.5	28.5	28.4	28.8	27.3	26.9	26.6
STATIC CRUSH (IN)																
Axle Height	11.2	NA	NA	3.4	5.6	5.8	6.9	7.6	8.6	9.6	10.2	8.0	6.8	5.6	4.5	NA
H-Point	20.1	NA	1.8	7.1	13.4	14.9	15.5	15.6	15.9	15.5	16.0	15.9	15.9	15.4	12.8	NA
Mid Door	23.6	NA	1.8	6.7	10.9	11.9	12.2	12.8	12.8	12.7	13.3	13.5	13.1	13.1	12.4	5.2
Window Sill	35.4	1.5	1.5	3.4	4.1	8.0	9.1	9.5	9.6	9.7	10.7	10.4	10.2	10.5	8.9	4.1
Window Top	53.1	NA	NA	NA	NA	NA	NA	3.1	3.4	4.3	3.9	3.7	4.3	2.8	2.4	2.0

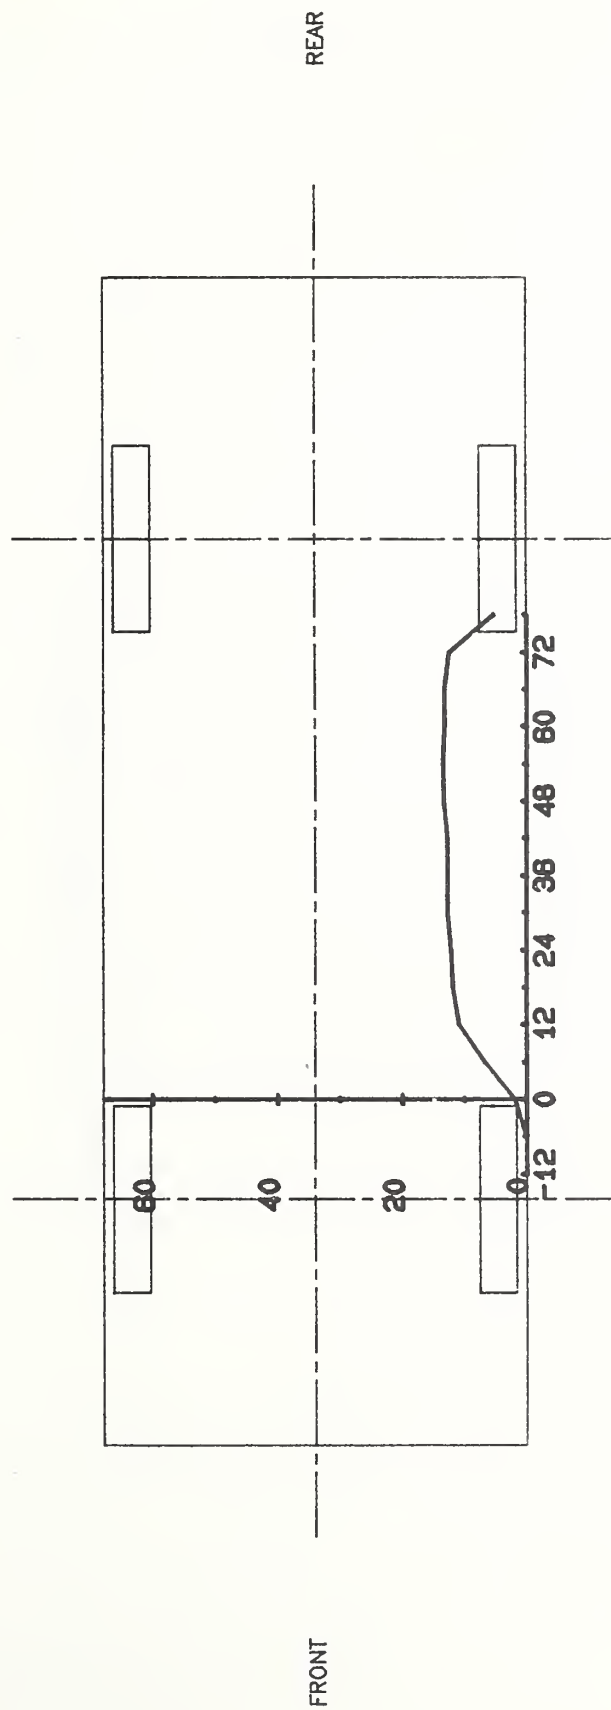
# VEHICLE EXTERIOR STATIC CRUSH PROFILE

PROFILE LEVEL EQUALS MID DOOR HEIGHT WHICH IS 23.6" ABOVE GROUND LEVEL  
 (0,0) EQUALS PROJECTED IMPACT POINT  
 SCALE FACTOR EQUALS 0.034

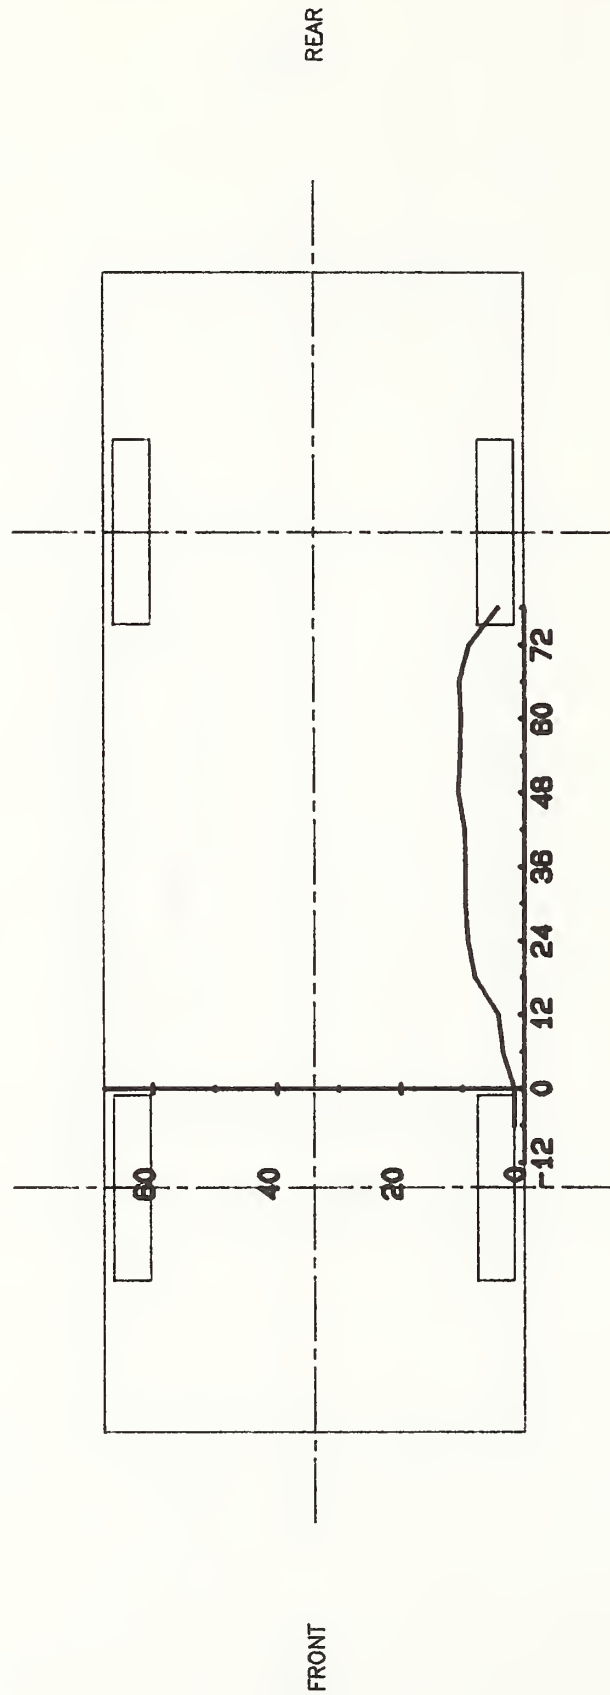
# VEHICLE EXTERIOR STATIC CRUSH PROFILE

PROFILE LEVEL EQUALS WINDOW SILL HEIGHT WHICH IS 35.4" ABOVE GROUND LEVEL  
 (0,0) EQUALS PROJECTED IMPACT POINT  
 SCALE FACTOR EQUALS 0.034

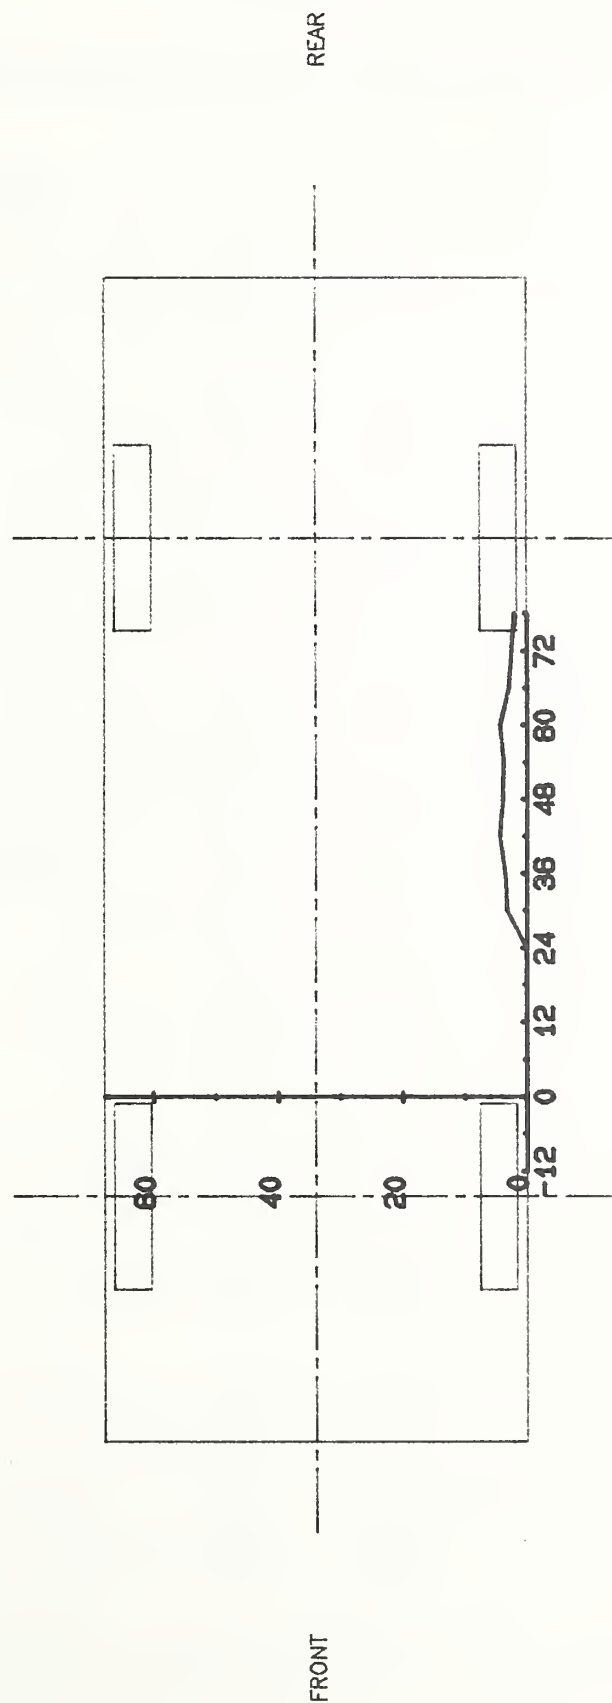
# VEHICLE EXTERIOR STATIC CRUSH PROFILE

PROFILE LEVEL EQUALS WINDOW TOP HEIGHT WHICH IS 53.1" ABOVE GROUND LEVEL  
 (0,0) EQUALS PROJECTED IMPACT POINT  
 SCALE FACTOR EQUALS 0.034

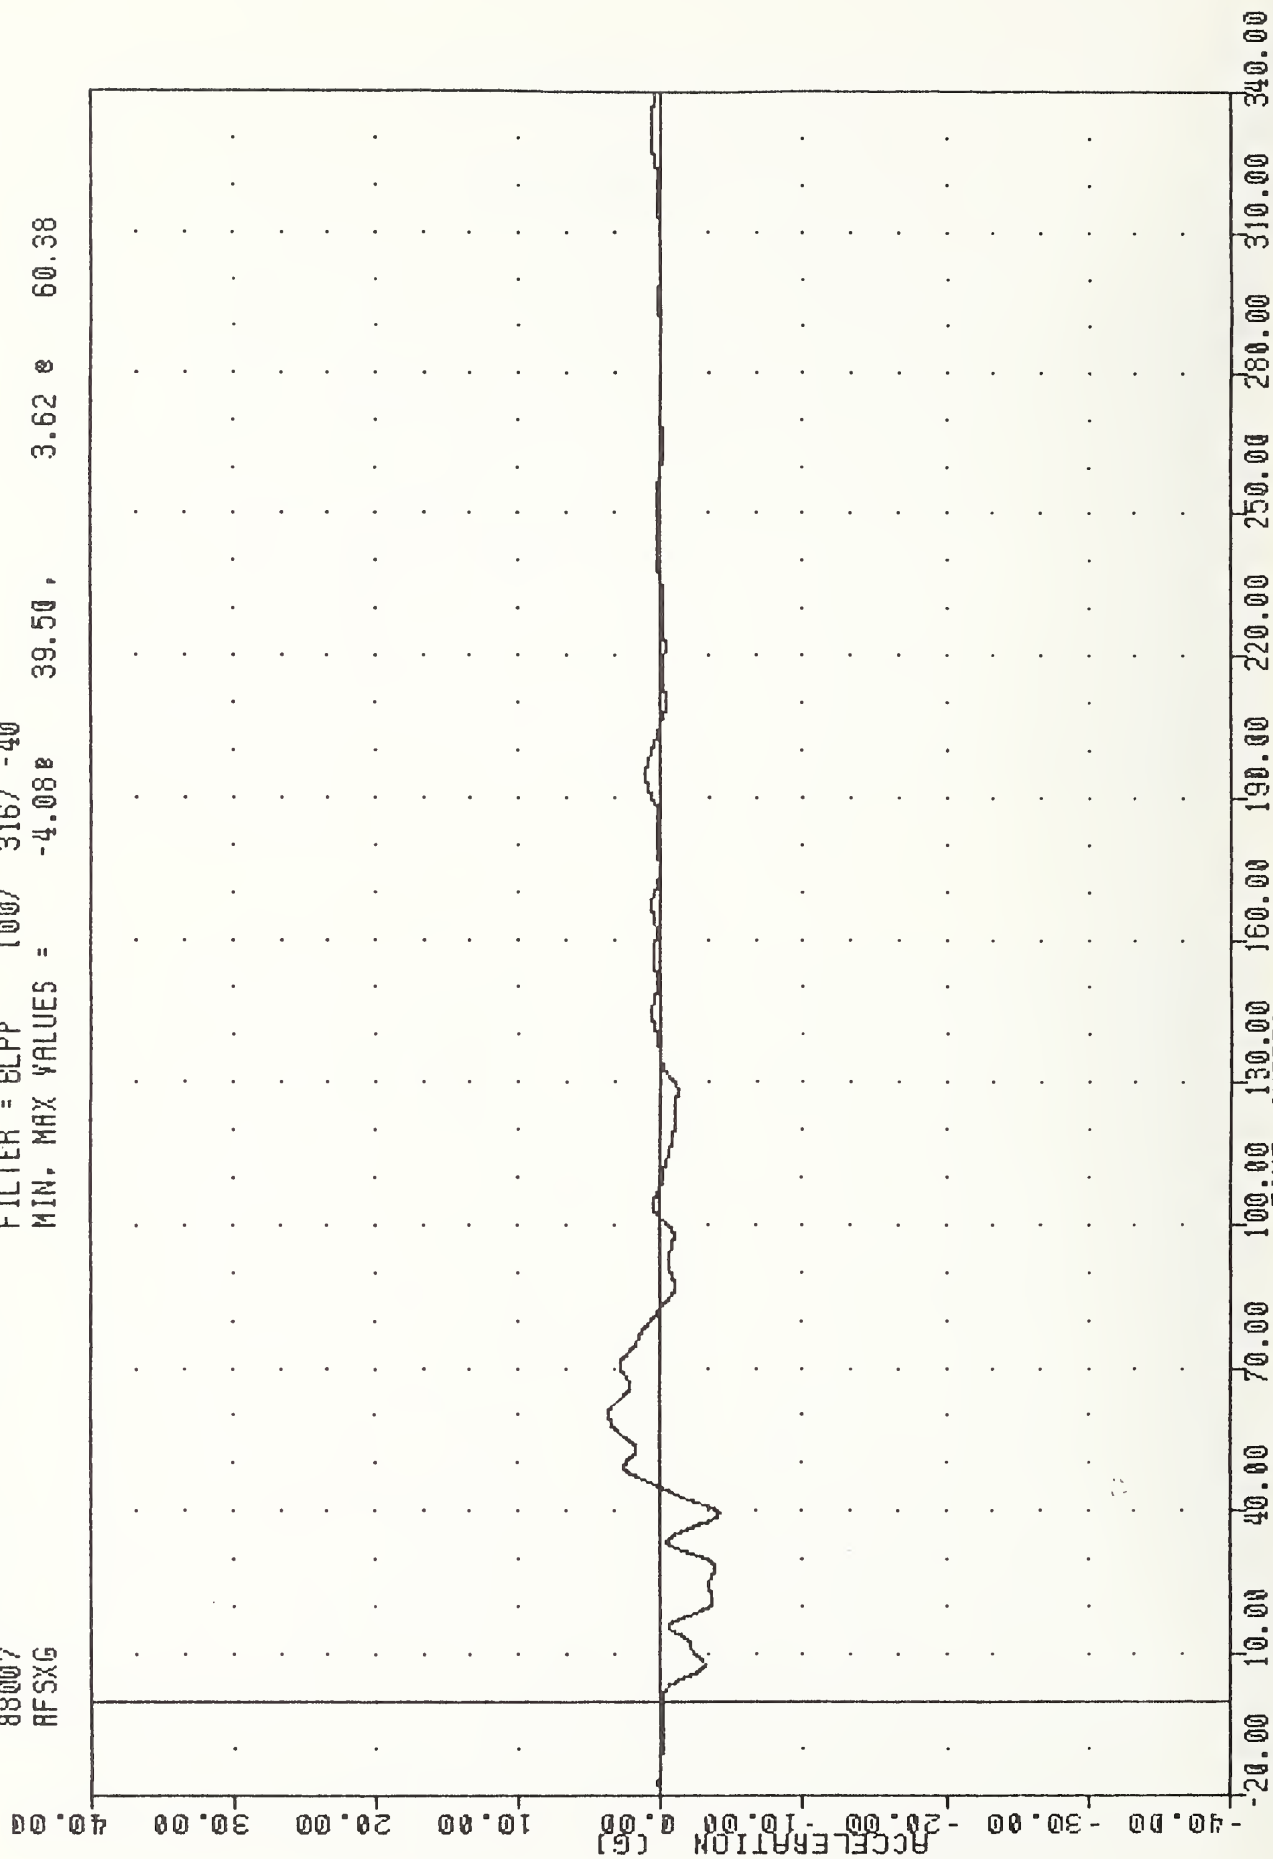
FILTER = BLPP 100/ 316/ -40  
 MIN. MAX VALUES = -4.08 39.50 , 3.62 60.38

MOVING DEFORMABLE BARRIER INTO 1985 CHEVROLET CELEBRITY  
 VEHICLE RIGHT FRONT SILL X AXIS ACCELERATION

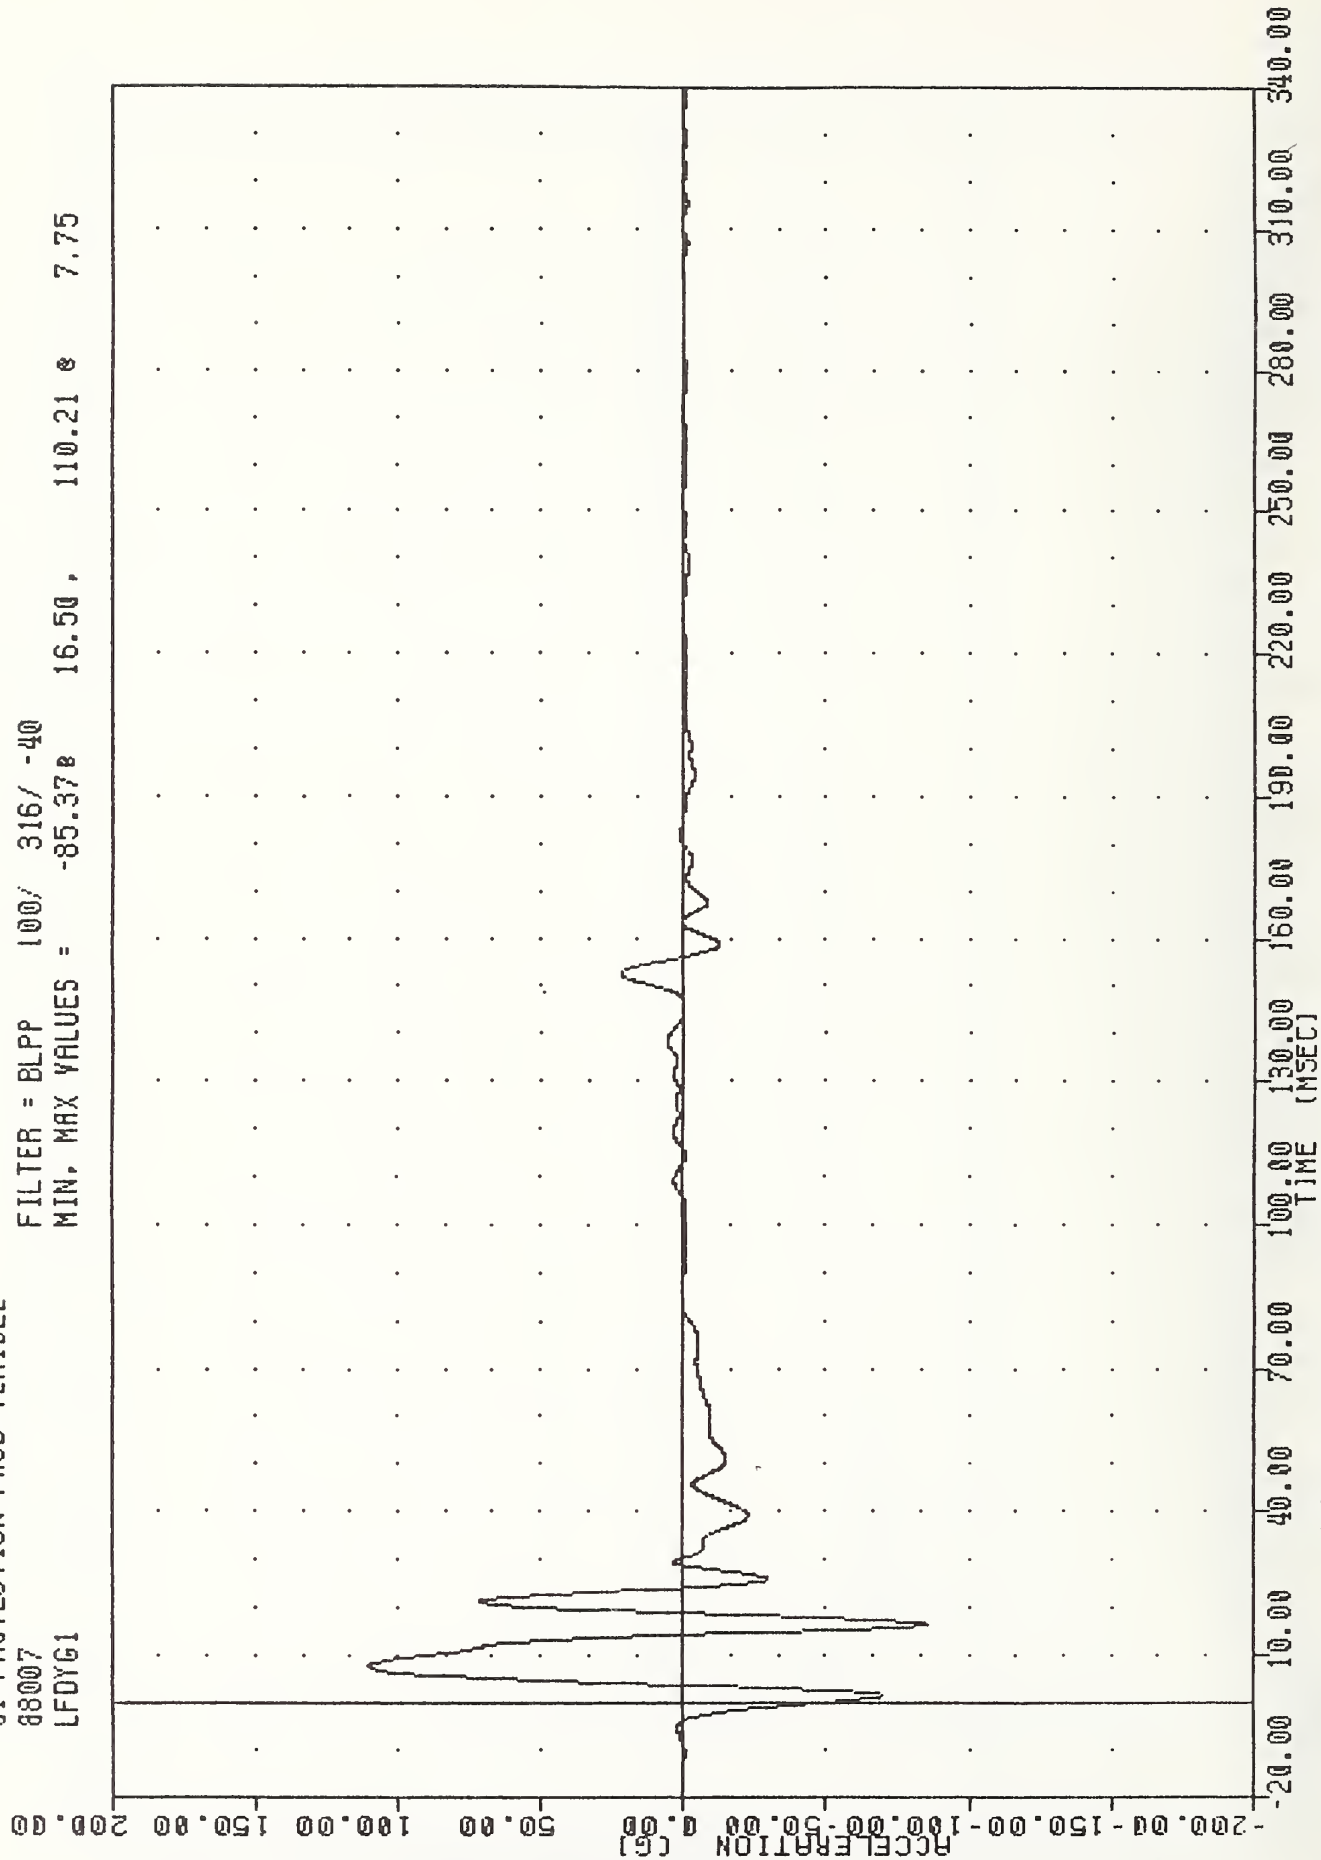
FILTER = BLPP 100/ 316/ -40  
 MIN, MAX VALUES = -85.37 16.50, 110.21 7.75

MOVING DEFORMABLE BARRIER INTO 1985 CHEVROLET CELEBRITY  
 VEHICLE LEFT FRONT DOOR (POSITION 6) Y AXIS ACCELERATION

6	LEFT FRONT DOOR CENTERLINE	107.3	-28.2	18.9				
	LATERAL	$\Delta V = 16.3 \text{ mph @ } 14.9 \text{ msec}$			110.2	7.8	85.4	16.5
8	MIDREAR OF LEFT FRONT DOOR	90.4	-28.9	19.1				
	LATERAL	$\Delta V = 28.2 \text{ mph @ } 11.5 \text{ msec}$			123.9	6.1	58.5	14.4
9	UPPER LEFT FRONT DOOR CENTERLINE	107.3	-28.9	33.9				
	LATERAL	$\Delta V = 18.4 \text{ mph @ } 30.0 \text{ msec}$			49.5	7.6	23.0	34.0
11	LEFT FRONT DOOR (THORAX)	93.2	-28.2	31.8				
	LATERAL	$\Delta V = 33.8 \text{ mph @ } 41.6 \text{ msec}$			97.3	9.3	33.4	28.6
11	LEFT FRONT DOOR (THORAX) FOAM BLOCK	90.8	-28.2	31.8				
	LATERAL	$\Delta V = 20.7 \text{ mph @ } 26.2 \text{ msec}$			106.5	8.8	64.9	28.1
12	LEFT FRONT DOOR (H-POINT)	93.8	-28.2	19.2				
	LATERAL	$\Delta V = 34.9 \text{ mph @ } 26.6 \text{ msec}$			151.4	8.4	88.6	17.0

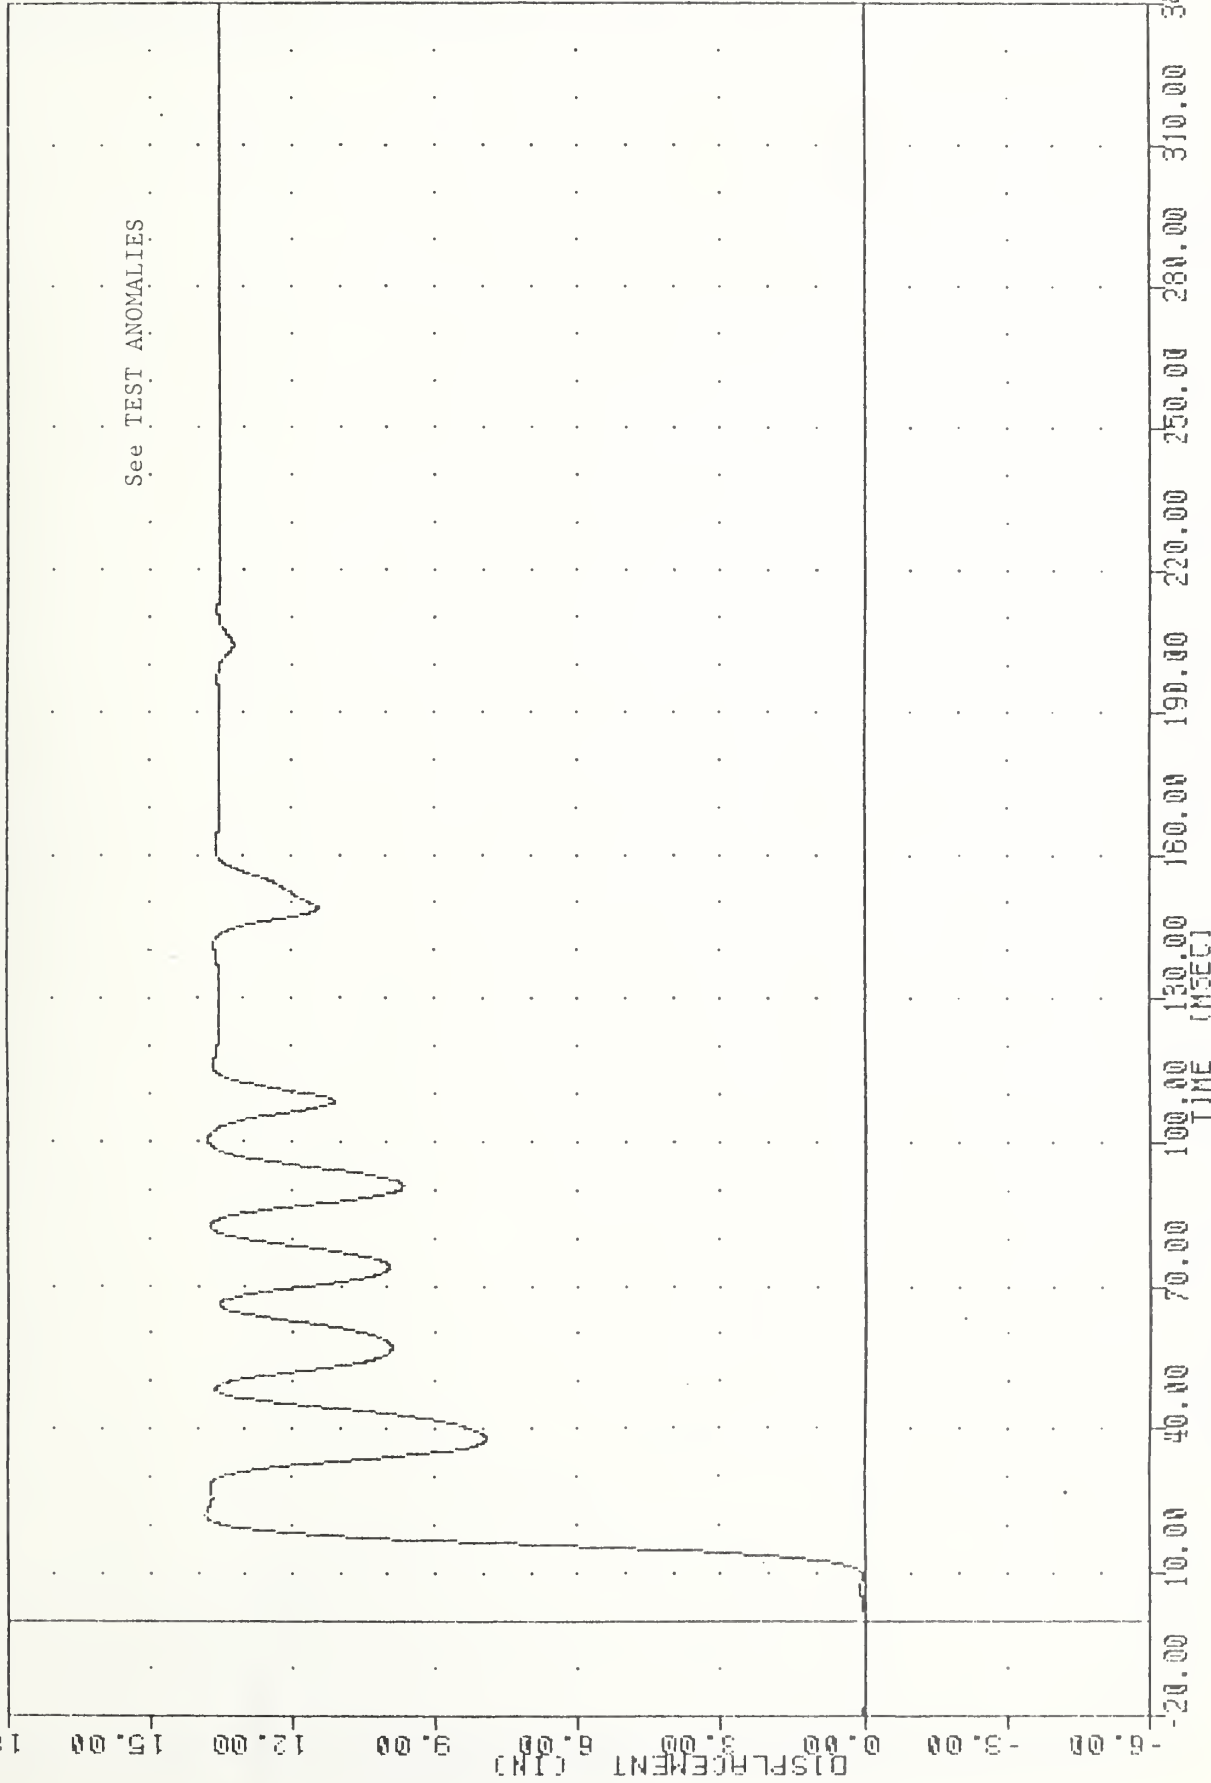
FILTER = ELPP 100/ 316/ -40  
 MIN. MAX VALUES = -0.01e -0.38, 13.81 e 22.13

MOVING DEFORMABLE BARRIER INTO 1985 CHEVROLET CELEBRITY  
 VEHICLE LEFT FRONT DOOR (THORAX) LINEAR POT

The left front door (thorax) linear potentiometer, LFDYD1, recorded questionable data after 15 milliseconds due to internal separation in the linear potentiometer.

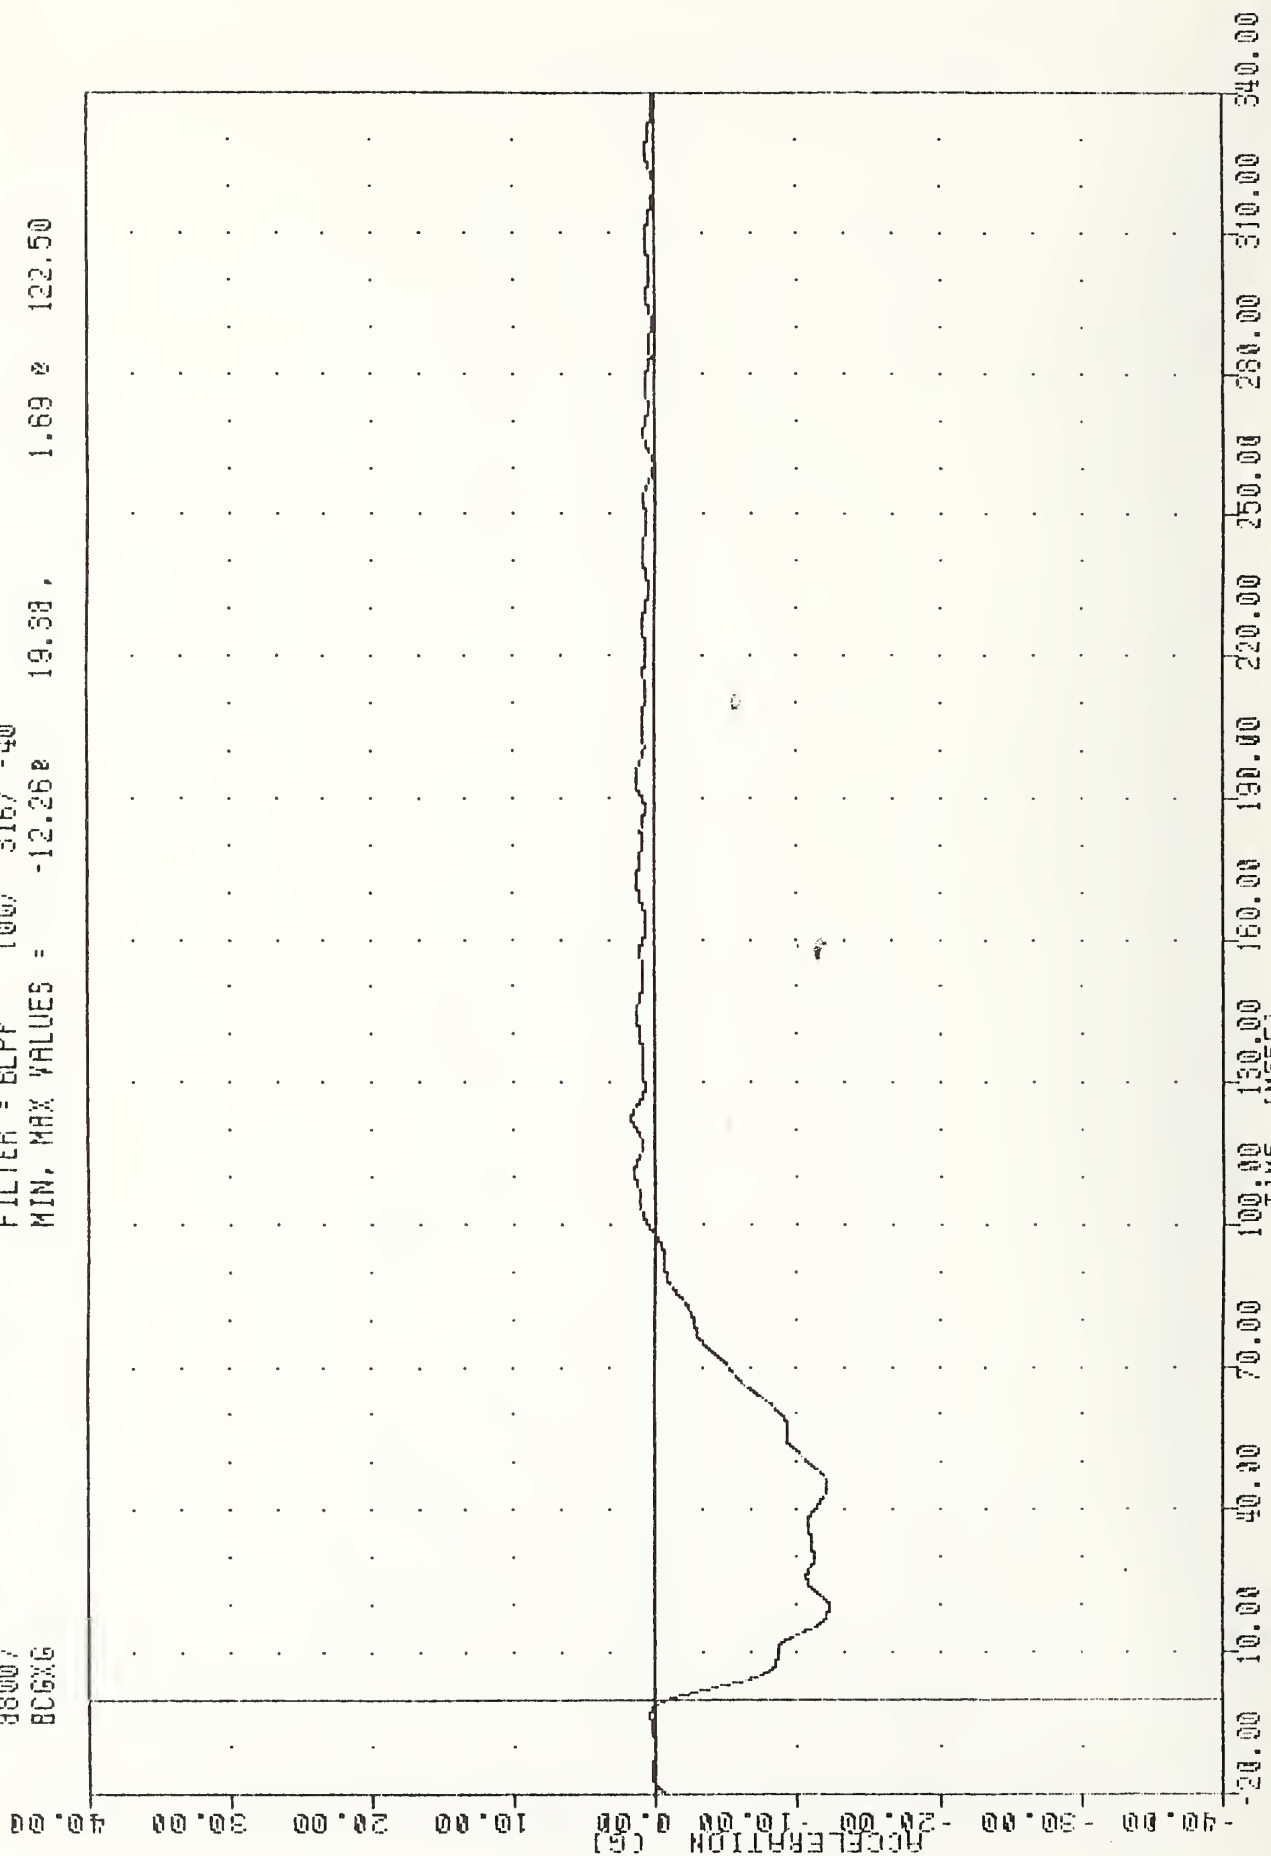
FILTER = BLPP 100/ 316/ -40  
 MIN. MAX VALUES = -12.26e 19.58 , 1.69 e 122.50

MOVING DEFORMABLE BARRIER INTO 1985 CHEVROLET CELEBRITY  
 BARRIER CENTER OF GRAVITY X AXIS ACCELERATION
